Rotating kiln tyres: lubricating between the tyre and shell

Walter Gebhart, Phillips Kiln Services, USA discusses the philosophy of lubricating between the tyre and kiln shell.

(Reprinted from World Cement, December 1995)

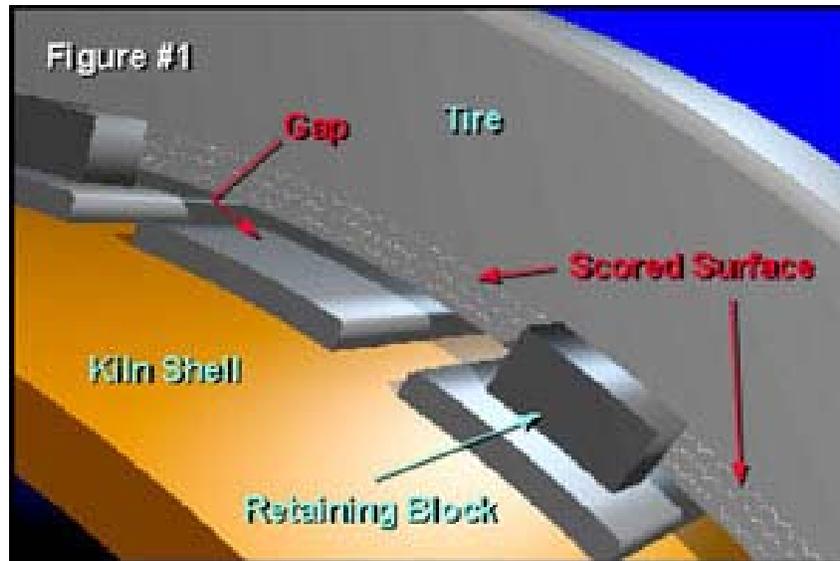
Since the tyres are loose around the shell they must be retained from shifting along the length of the shell. This is done in a variety of ways but is usually accomplished by a simple set of blocks welded to the support pads or directly to the shell on either side of the tyre. Kiln tyres will normally sit against the uphill side retaining blocks. The migration of the tyre produces a circumferential sliding action of the tyre against its retainers. The force with which the tyre sits against its retainers depends on a number of factors, mainly roller skew, slope and alignment. Radial sliding between the retainers and the tyre also occurs due to the gap discussed previously. Consequently the scoring marks on the side of the tyres caused by the retaining blocks are a combination of radial and circumferential sliding and look like the pattern shown in Figure 1.
